# YOUR Inspection Report

64 Mordecai Lincoln Road - The Residency and Mill  
Scituate, MA 02066

RE: Report No. 2044  
64 Mordecai Lincoln Road - The Residency and Mill  
Scituate, MA  
02066

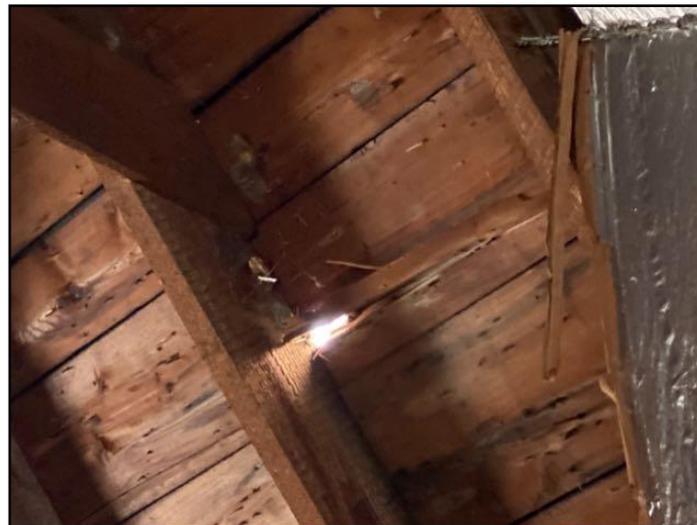
The asphalt roof covering on the mill structure is well into its useful life and nearing full depreciation. There is an open void on the front gable roof line that is actively allowing water to gain entry to the structure. This needs to be repaired immediately. Others areas of the roof sheathing, from interior examination, appear to be in decent condition. The condition of the shingle roof covering itself is heavily worn. These are non-architectural grade shingles that are most likely past their anticipated lifespan. Complete roof covering replacement would be highly recommended in the near future to properly protect the structure.

*Puncture on front gable roof line*

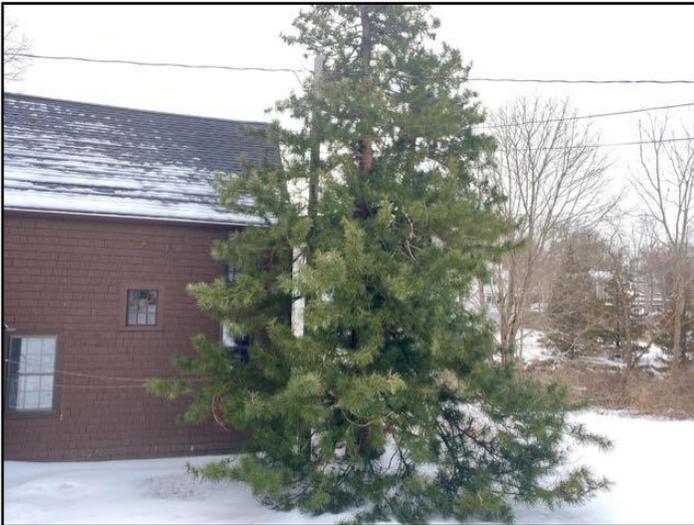
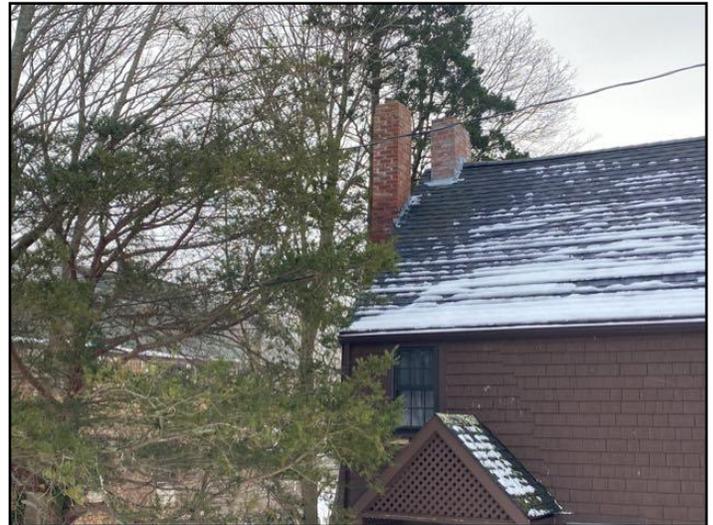
There are numerous trees that are growing nearly in contact with the residence structure. This is generally not recommended for a variety of reasons: (1) vegetation near exterior siding tends to trap moisture against the siding, increasing the potential for decay in building fabric; (2) vegetation in contact with a structure increases the likelihood of insects transferring into the structure and; (3) the roots of trees have been noted to disrupt nearby foundation materials over time. Removal of mature trees within six feet of any structure should be strongly considered. Discuss with arborist.

Trees too close to structure

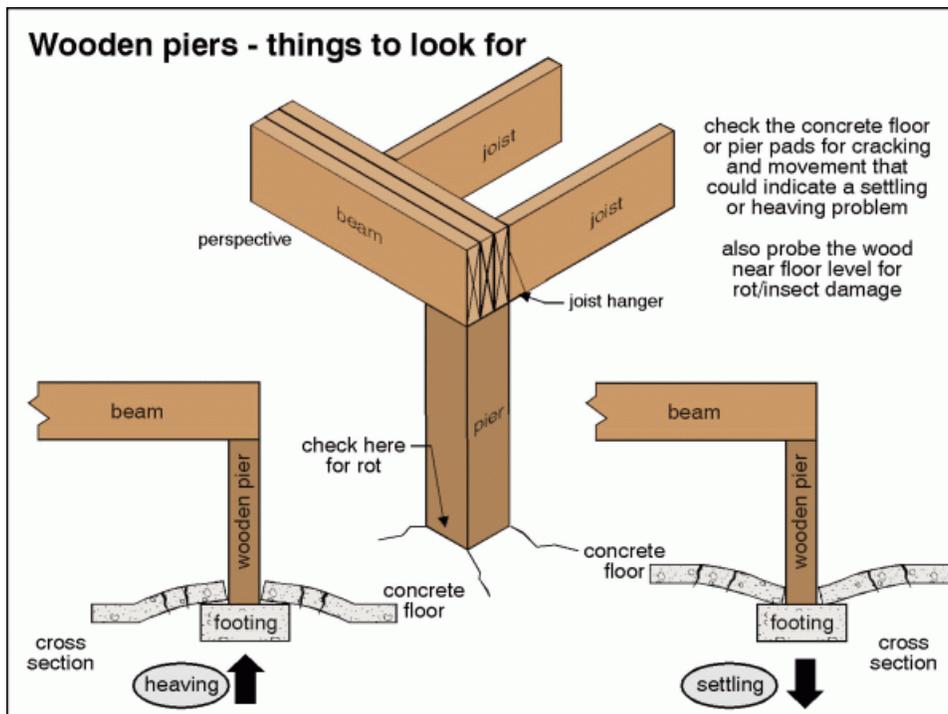
There are several older, cedar support posts in the basement of the residence. These feature have sustained significant damage from exposure to water. They should be the subject of through evaluation by a qualified contractor.

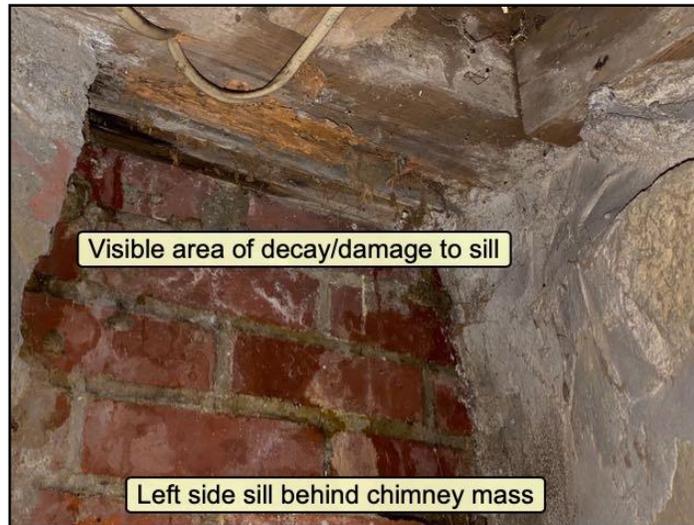
There is a visible area of decay/damage to the left side wooden sill of the residence structure. This feature can be seen from inside the basement, fronting the chimney mass. The feature was not directly accessible due to standing water in the basement. Further evaluation will be needed to determine the extent of damage and need (if any) of repairs.

*Left sill of residence structure*

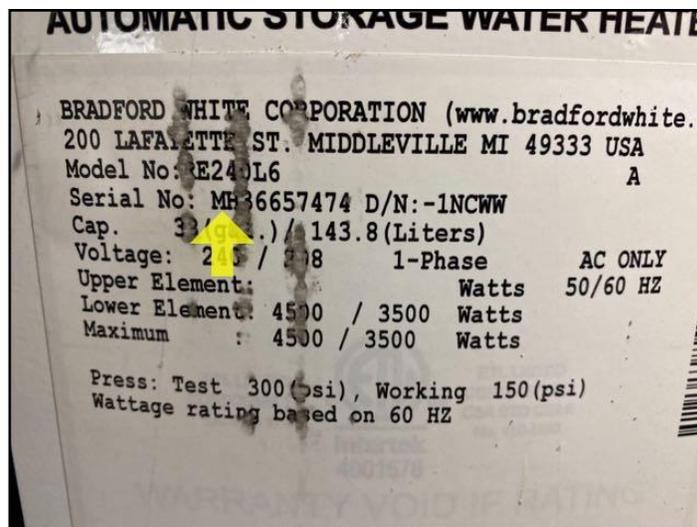
It should be noted that the electric water heater in the basement of the residence structure is 7 years old. These devices typically have a life span of 8-10 years. Replacement for the device should be anticipated in the near future.

*Age embedded in serial number*

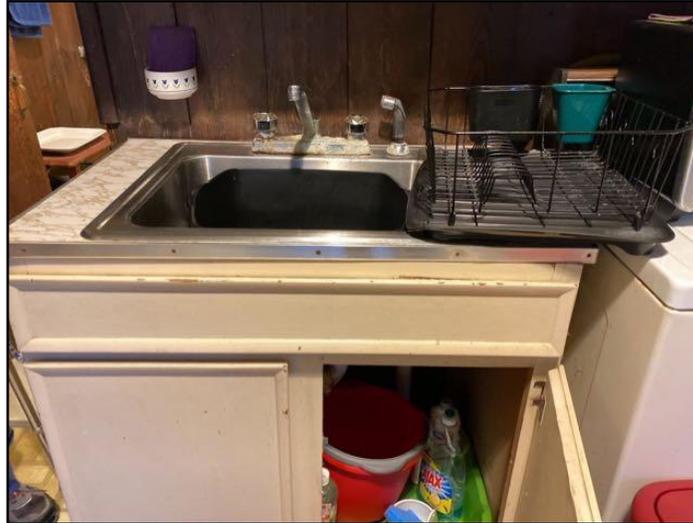
The drain for the kitchen sink has apparently failed. It was not actually tested, per the owner's request, but it would appear that a basin is used to prevent water from entering the drain. Many of the features and equipment in the kitchen are at levels of near-exhaustion. Comprehensive repairs and replacement, starting with any leaking water lines and drains, will be needed. Relatively major investment is recommend.

*Dilapidated equipment*

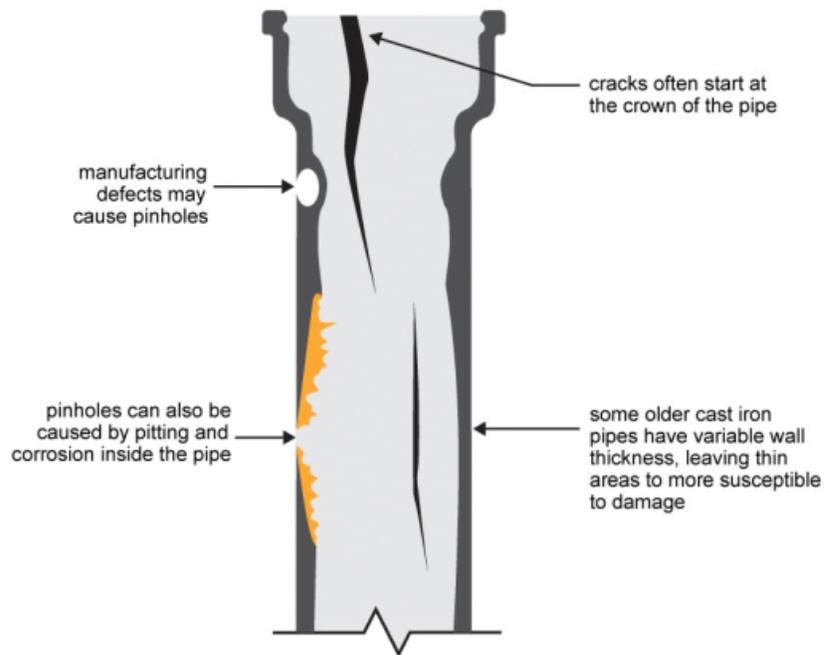
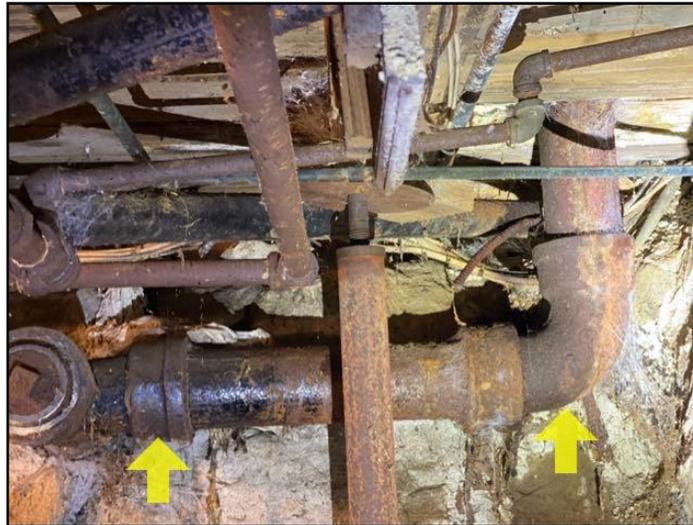
There is a fairly significant amount of older, cast iron drain line in the basement. These lines are most likely original to the house, making them nearly 100 years old. Cast iron oftentimes will rust from the inside out and generally have an anticipated life span of 50-70 years. While the overall condition of these lines is currently fair, areas of scabbing and rusting were noted - especially at pipe unions on horizontal runs. While not an immediate concern the cast iron drain lines in the home will need to be replaced in the near future. Recommend you consider and consult with a licensed plumber.

Aged and rusting cast iron drain lines

*Aged and rusting cast iron drain lines*

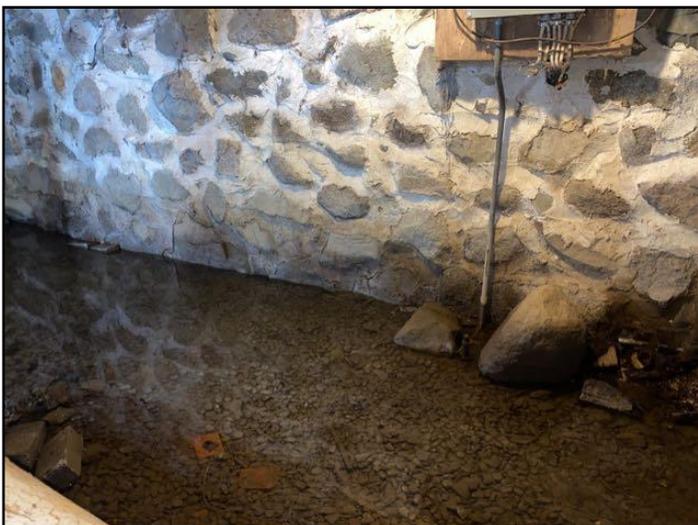
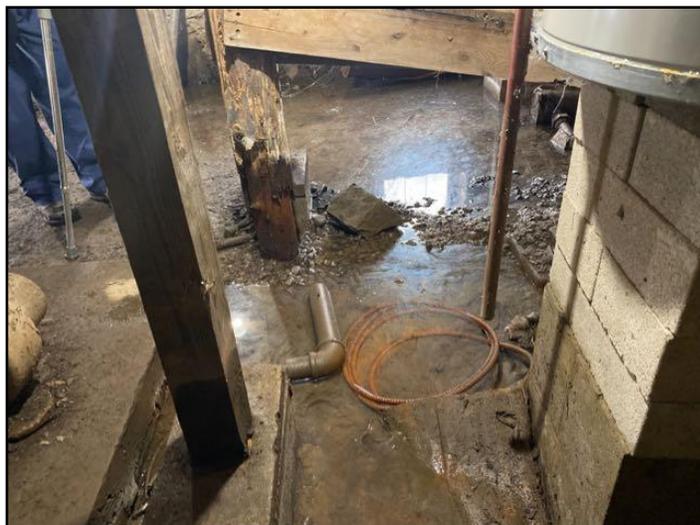
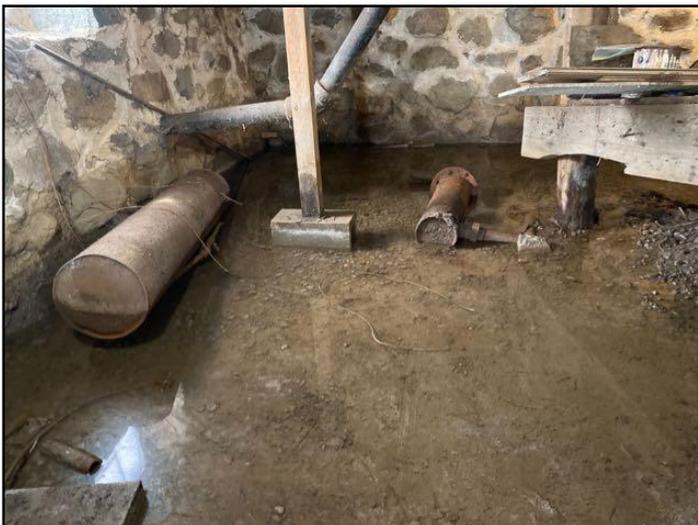
At the time of this site visit there was at least three to four inches of standing water covering at least 50-75% of the basement floor. Given the condition of piping, framing and other mechanical components in the basement, this has been a chronic condition negatively impacting the building -perhaps for decades. Comprehensively, this is the most important - and challenging - issue regarding the long term interest and preservation of the structure. Moisture readings taken from many of the building's floor framing in the basement were high, (from 25-90%). This condition contributes to rusting on metal drains and structural supports, decay in wood framing members and the increased likelihood of mold and/or mildew growth. As noted elsewhere in this document, some structural components have been heavily impacted by this wet condition. Consultation with qualified contractors will be needed to devise a comprehensive list of strategies and solutions to correct this environment.

*Standing water in basement*

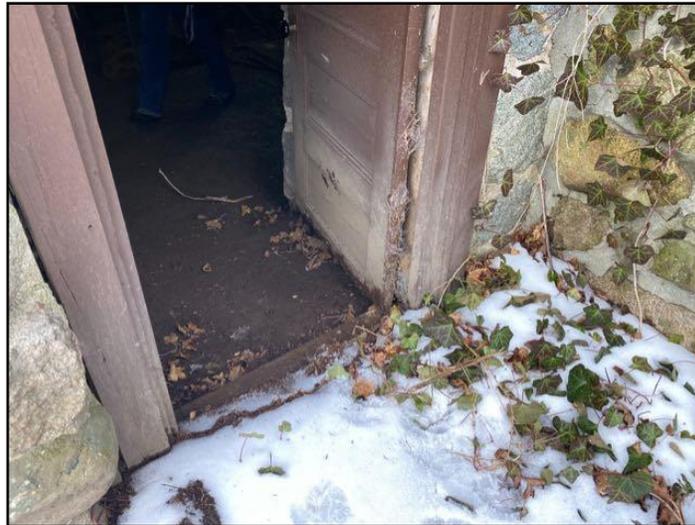
*Another water entry point*

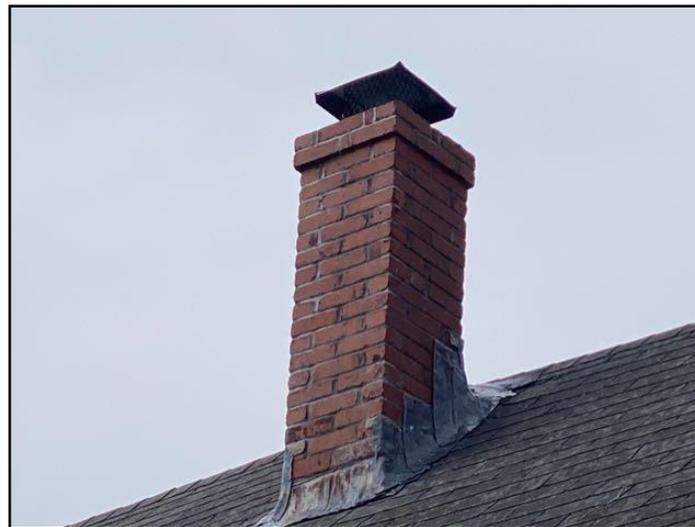
*Masonry chimney on mill - abandoned*

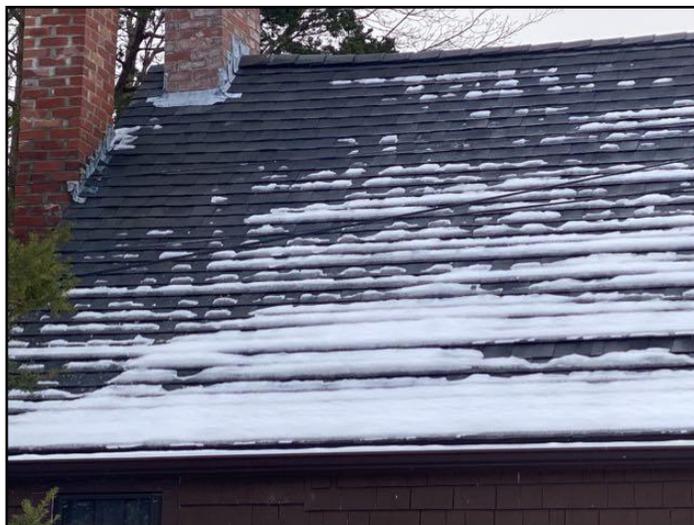
Some portions of the roof for both the residence and the mill were covered with recent snow fall. This limited my ability to visually evaluate some portions of the roof coverings.

*Snow on roof lines*

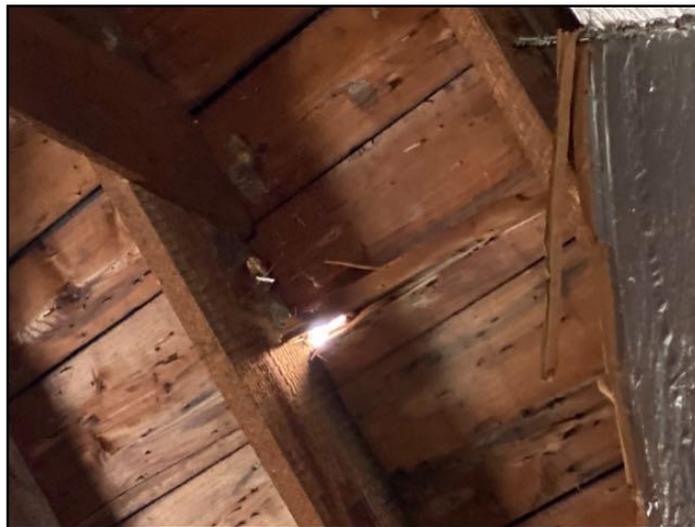
The asphalt roof covering on the mill structure is well into its useful life and nearing full depreciation. There is an open void on the front gable roof line that is actively allowing water to gain entry to the structure. This needs to be repaired immediately. Others areas of the roof sheathing, from interior examination, appear to be in decent condition. The condition of the shingle roof covering itself is heavily worn. These are non-architectural grade shingles that are most likely past their anticipated lifespan. Complete roof covering replacement would be highly recommended in the near future to properly protect the structure.

*Puncture on front gable roof line*

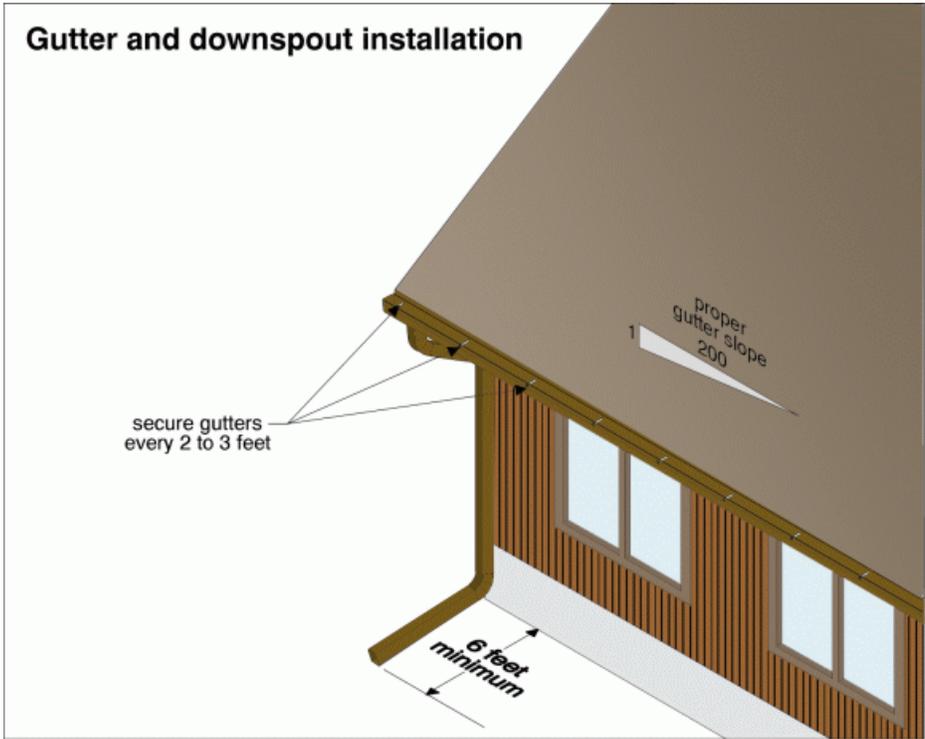
Gutters and downspouts needed

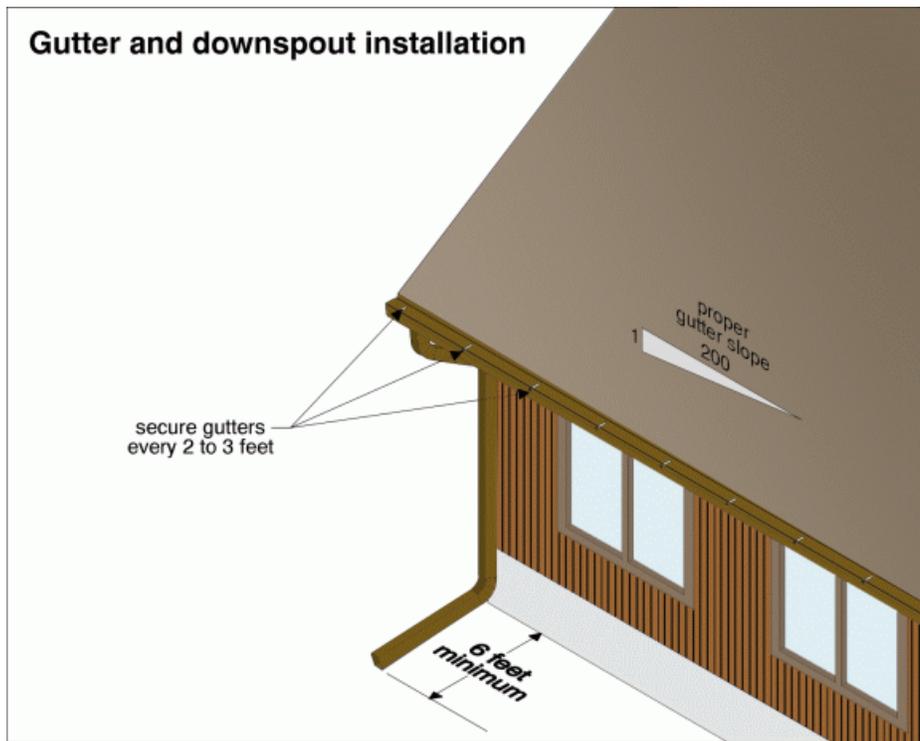
### Gutter and downspout installation

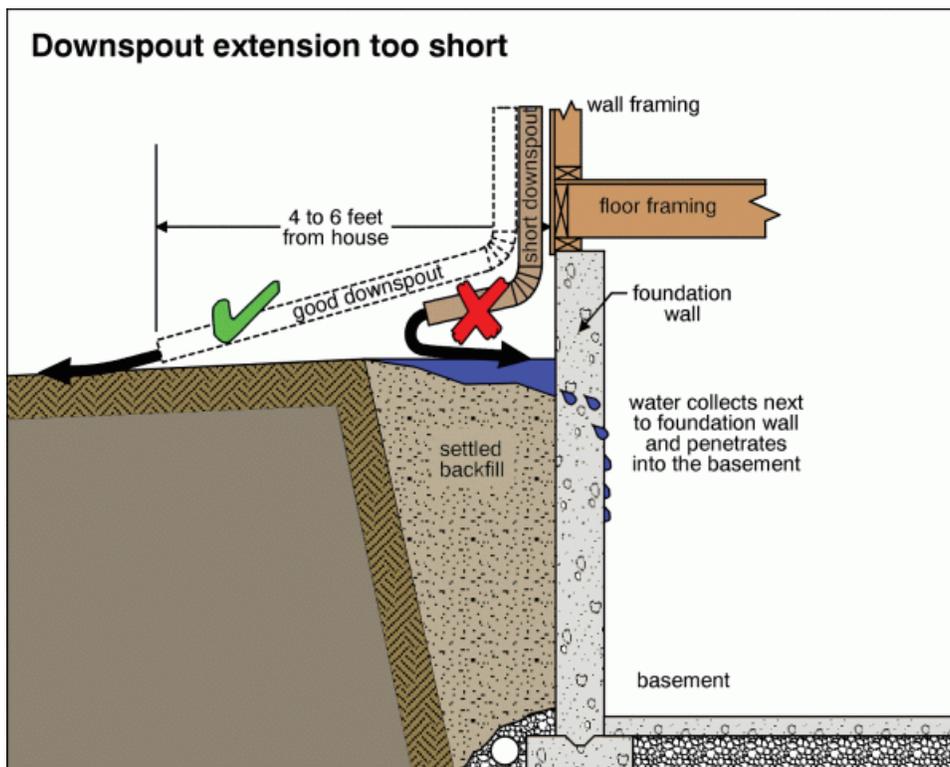
### Downspout extension too short

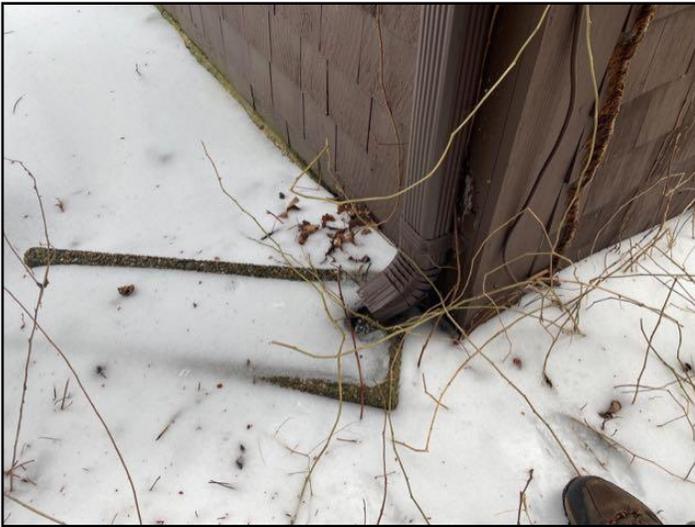
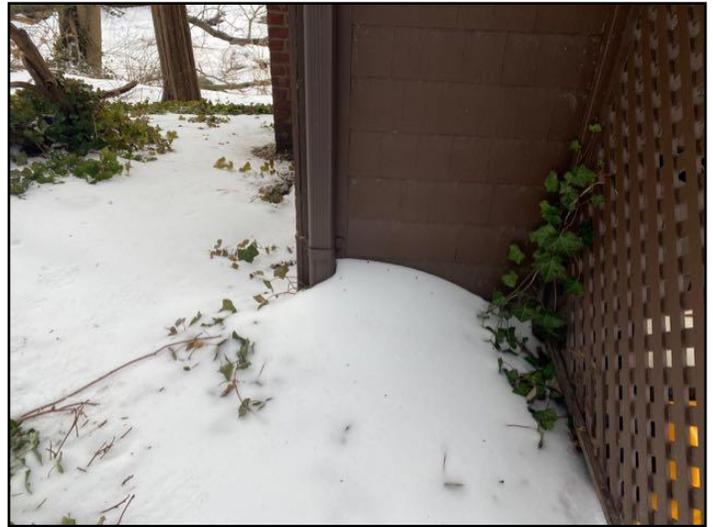
*Discharge too close to building*

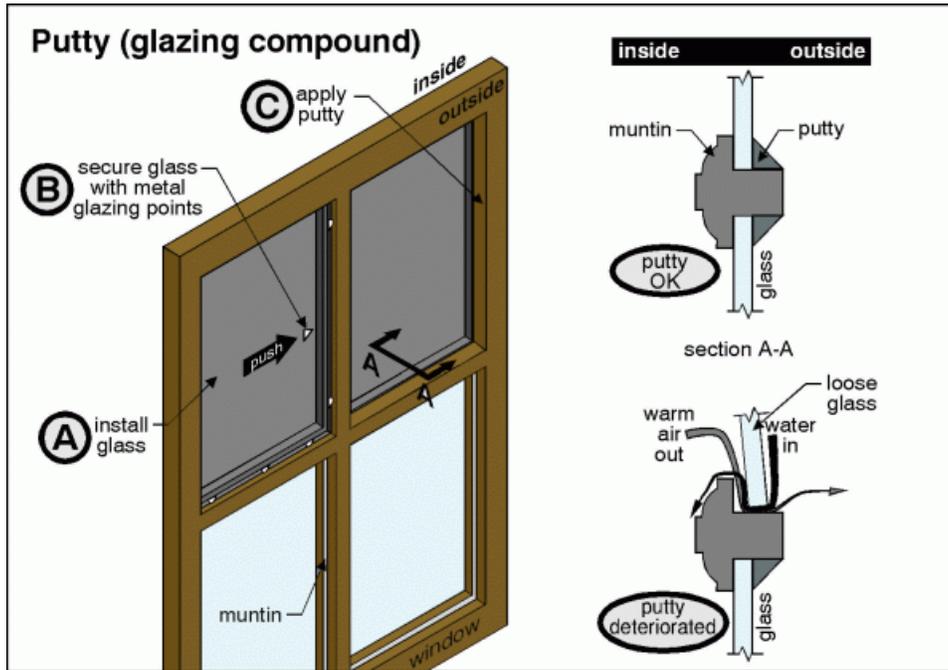
Example of failing window glazing on sash

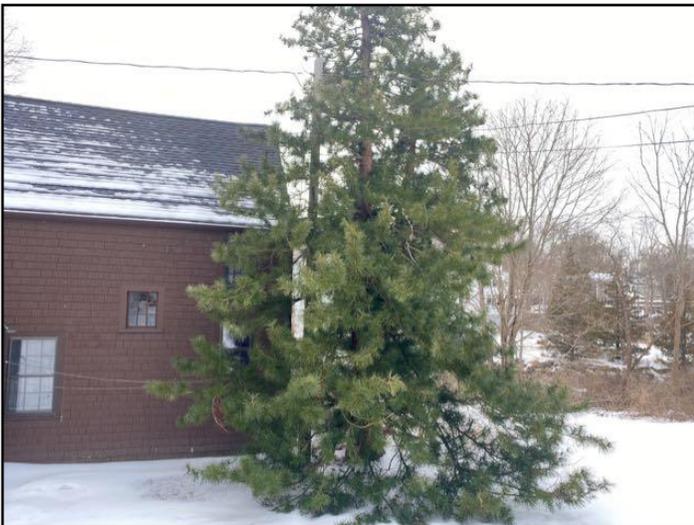
Trees too close to structure

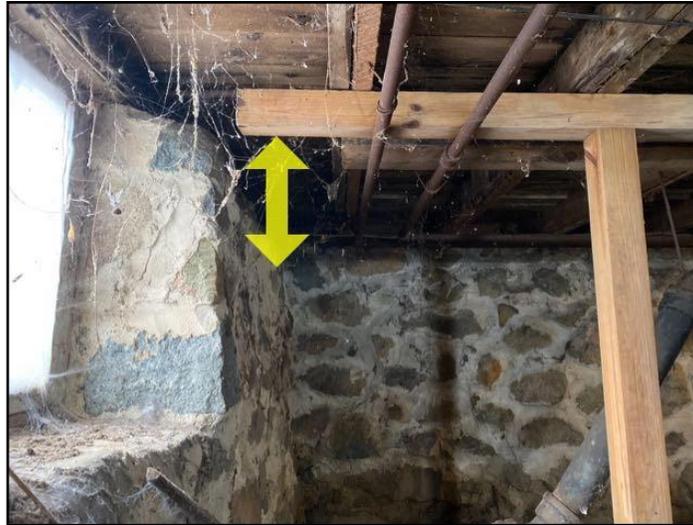
*Under-supported beam?*

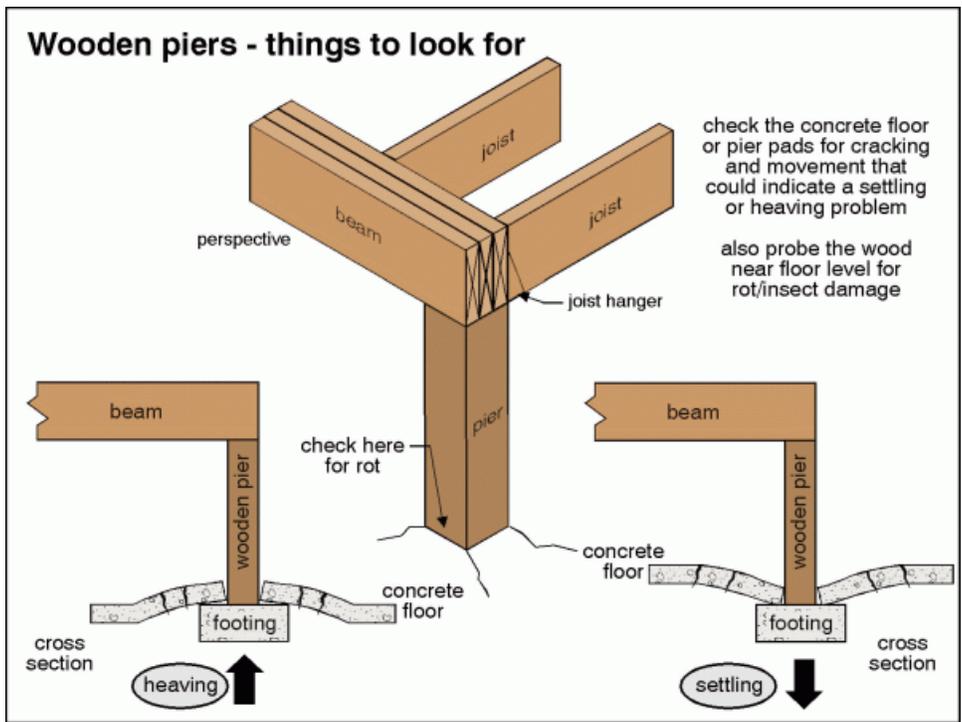
Heavy decay to cedar posts

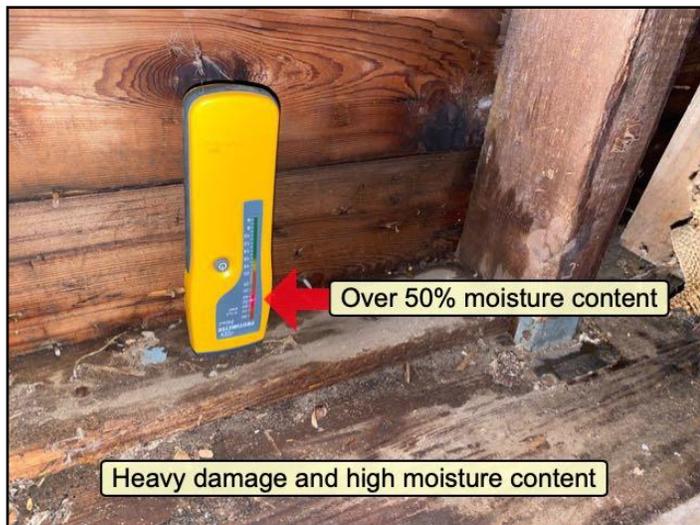
First floor, rear framing and flooring

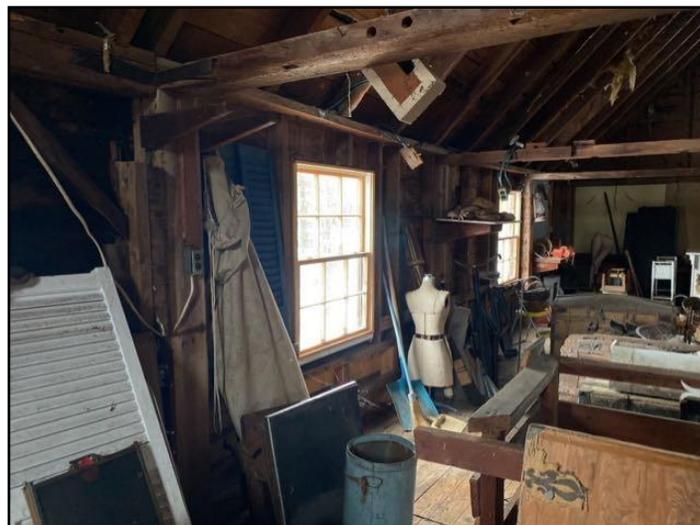
Second floor, overview of impacted area

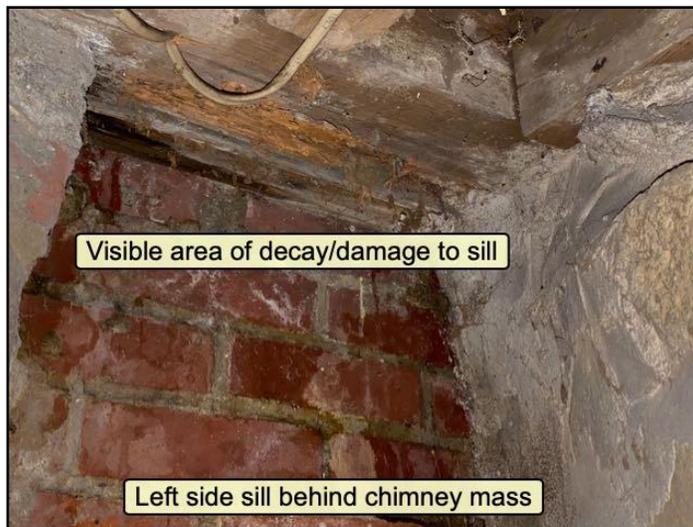
Left sill of residence structure

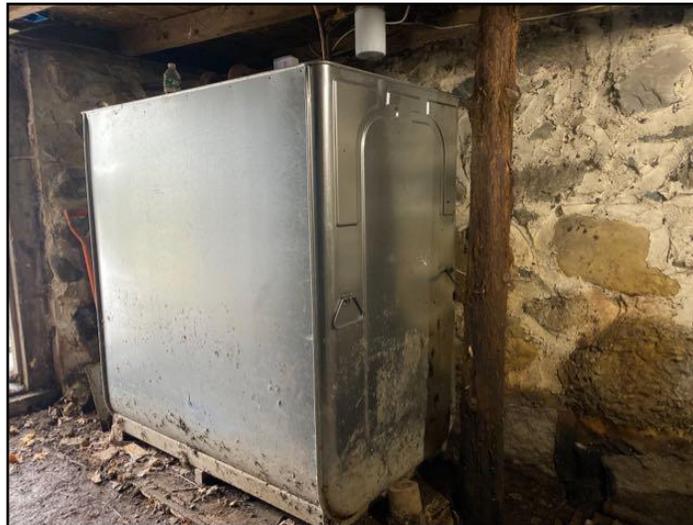
*Tank not evaluated*

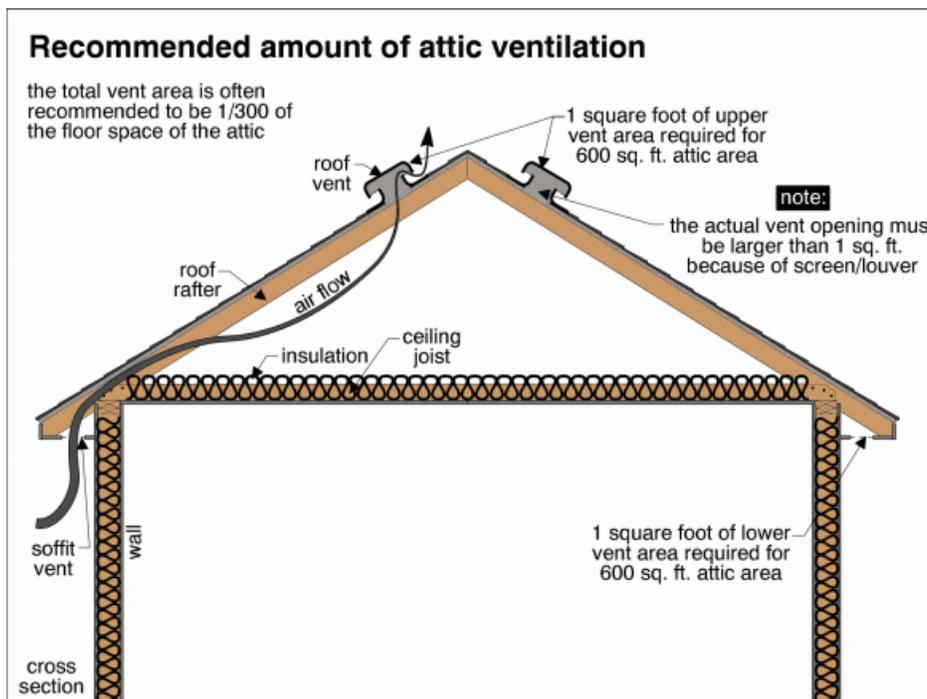
**23. Condition:** • Inadequate

While the attic space in the residence structure was not directly accessible, the unfinished attic space \*may\* not be sufficiently ventilated. Proper ridge and/or soffit venting could not be confirmed. Evaluated further with a qualified contractor and improve as needed.

**Implication(s):** Chance of condensation damage to finishes and/or structure

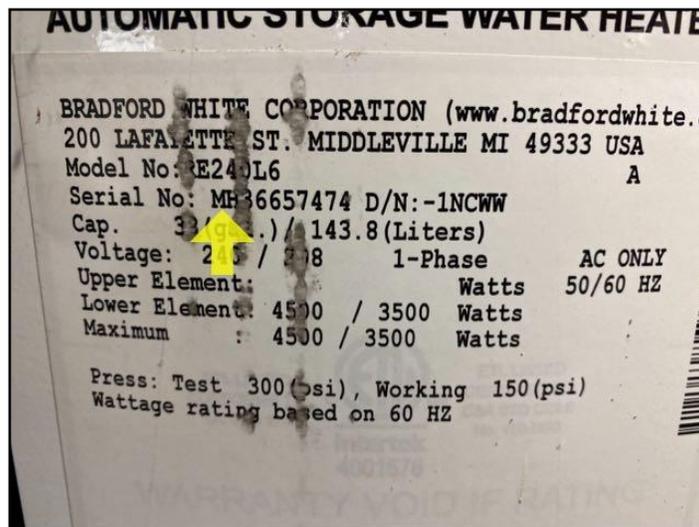
**26. Condition:** • Near end of life expectancy

It should be noted that the electric water heater in the basement of the residence structure is 7 years old. These devices typically have a life span of 8-10 years. Replacement for the device should be anticipated in the near future.

**Implication(s):** No hot water

*Age embedded in serial number*

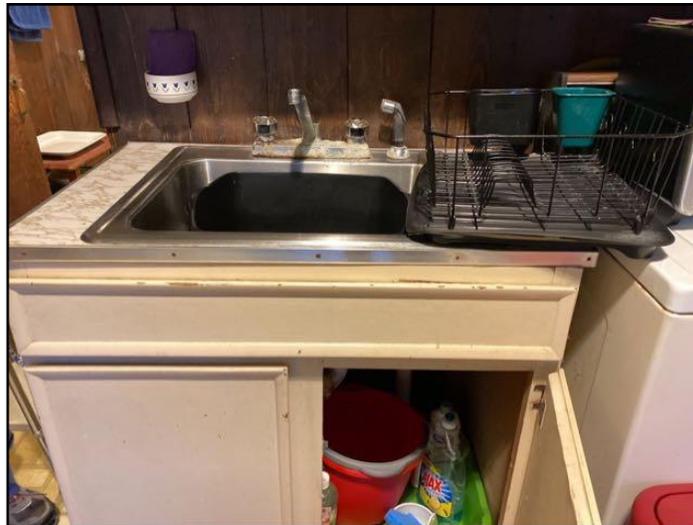
### **27. Condition:** • Leak

The drain for the kitchen sink has apparently failed. It was not actually tested, per the owner's request, but it would appear that a basin is used to prevent water from entering the drain. Many of the features and equipment in the kitchen are at levels of near-exhaustion. Comprehensive repairs and replacement, starting with any leaking water lines and drains, will be needed. Relatively major investment is recommend.

**Implication(s):** Sewage entering the building

*Dilapidated equipment*

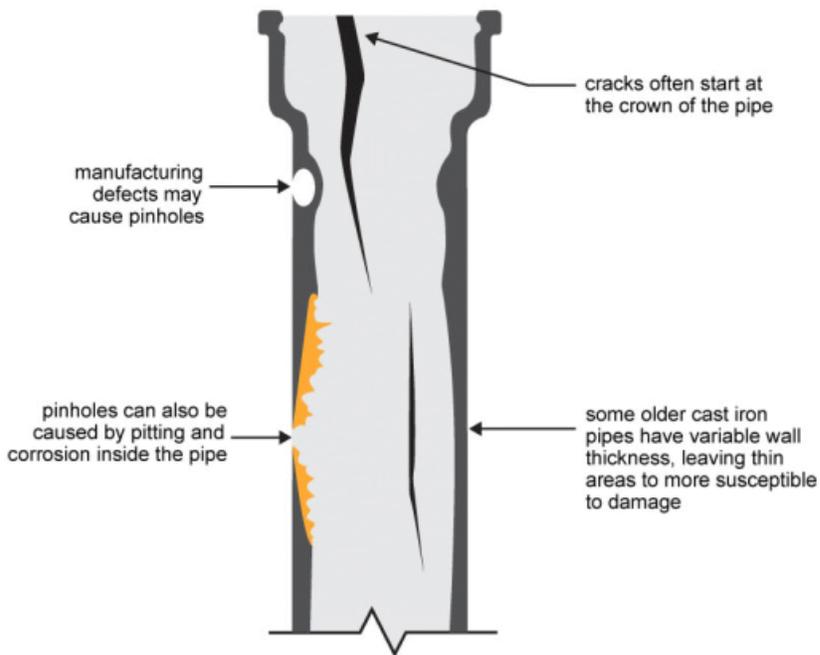
### **28. Condition:** • Rust

There is a fairly significant amount of older, cast iron drain line in the basement. These lines are most likely original to the house, making them nearly 100 years old. Cast iron oftentimes will rust from the inside out and generally have an anticipated life span of 50-70 years. While the overall condition of these lines is currently fair, areas of scabbing and rusting were noted - especially at pipe unions on horizontal runs. While not an immediate concern the cast iron drain lines in the home will need to be replaced in the near future. Recommend you consider and consult with a licensed plumber.

## Pinholing and cracks in cast iron stacks

Aged and rusting cast iron drain lines

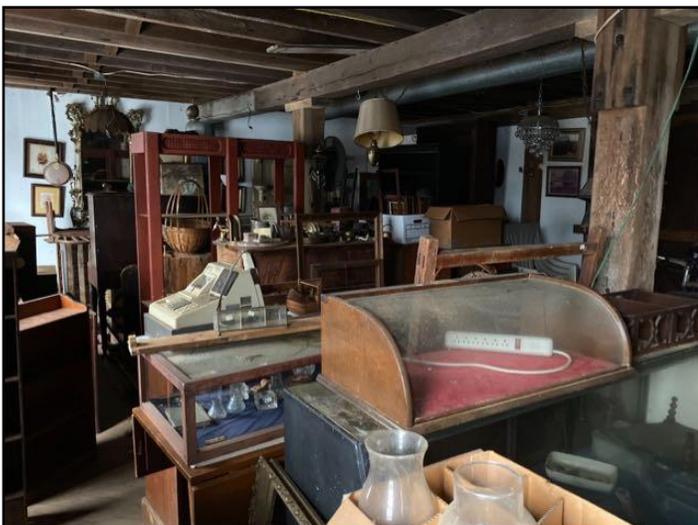
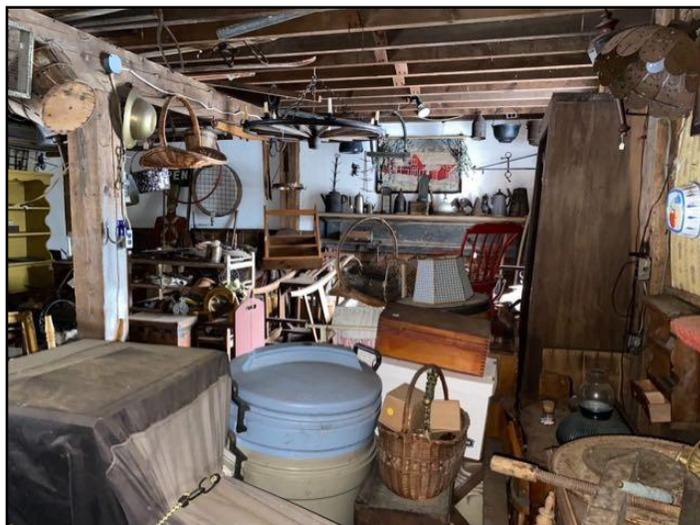
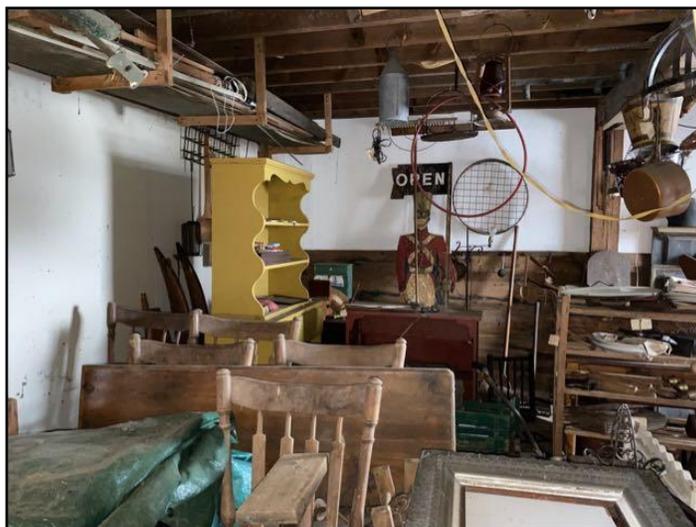
The interior of both the residence and mill structure was extremely hard to evaluated at the time of this inspection. One of the owners of the residence was currently working in the home and stored personal items and furniture covered and obscured nearly every wall and floor surface on both floors, in both buildings. It is strongly recommended that the interior of the these buildings be reevaluated once these items have been removed.

Stored items in mill structure

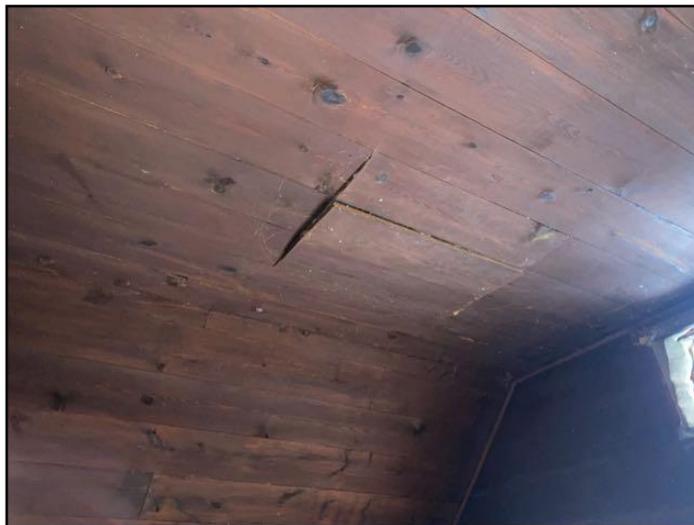
**30. Condition:** • Loose sections

There appeared to be an opening or hatch in the middle of the ceiling on the second floor of the residence structure. The hatch was not accessible and the owner said the panels of the opening were loose and not safe. Further evaluation will be needed, as will likely repairs.

**Implication(s):** Damage or physical injury due to falling materials

*Loose sections in ceiling paneling*

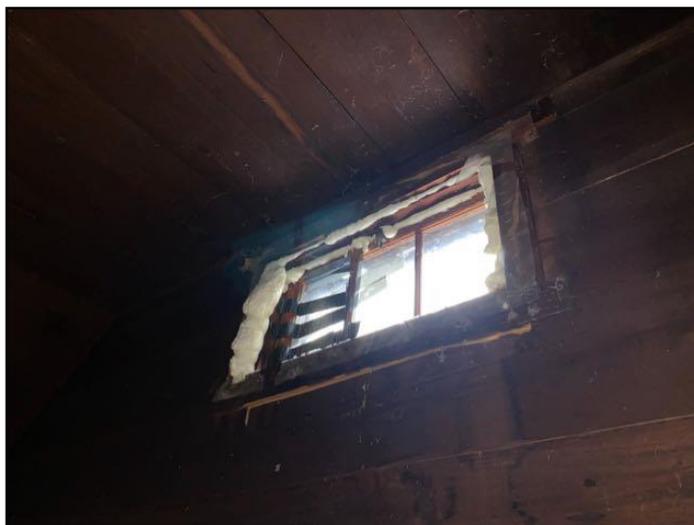
**31. Condition:** • Broken

The right side gable window on the second floor of the residence structure is heavily damaged. This feature will need to be replaced by a qualified contractor.

**Implication(s):** Chance of water entering building | Physical injury | Increased heating and cooling costs | Reduced comfort

*Residence- broken and damaged window*

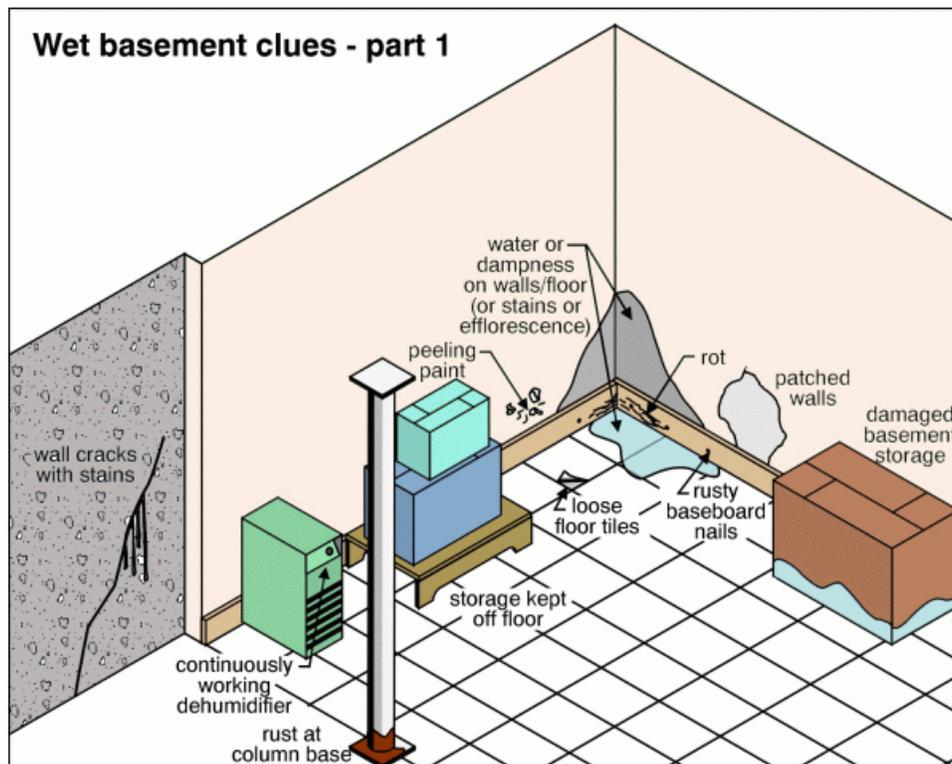
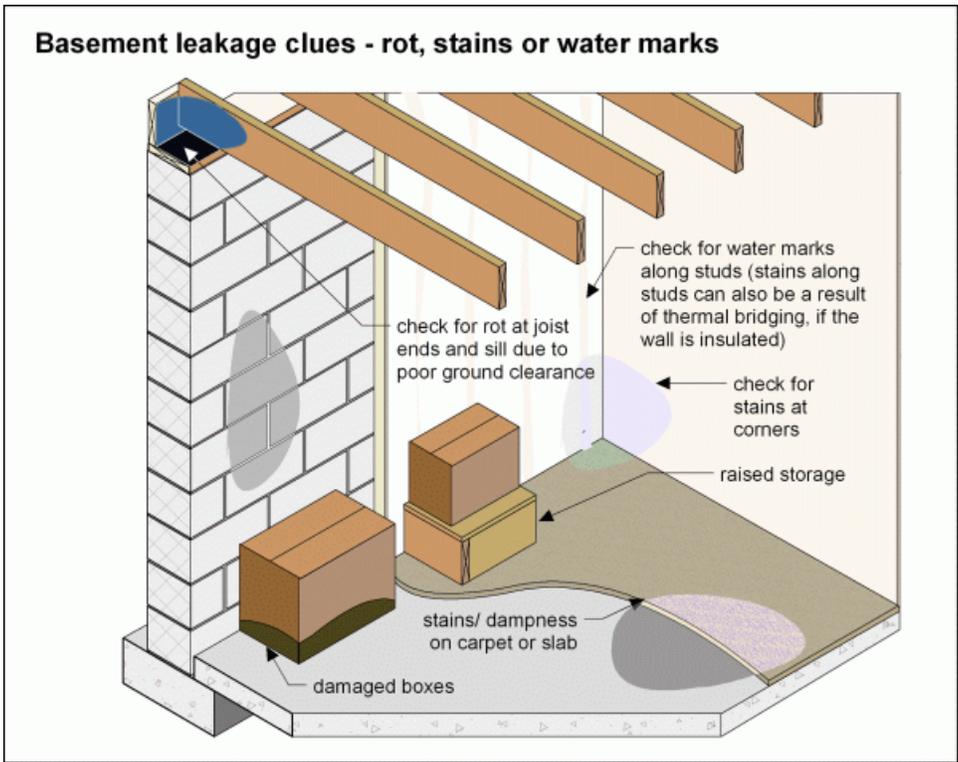
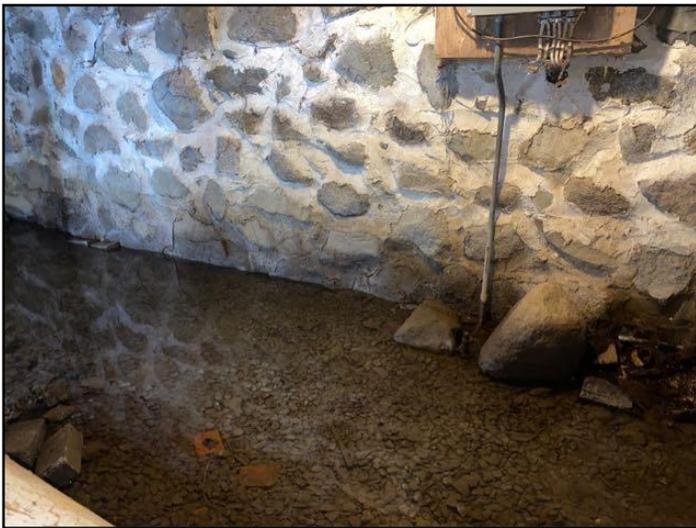
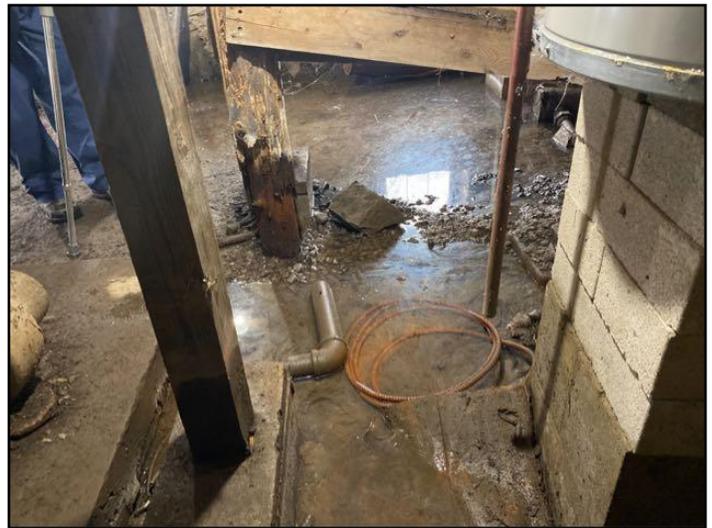
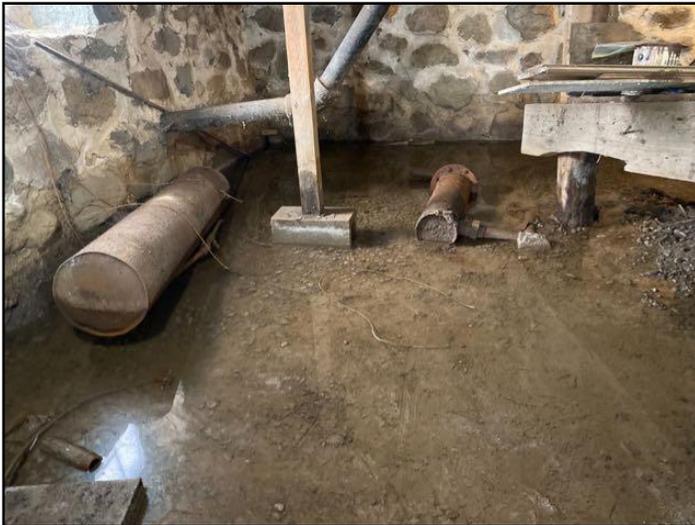
#### **33. Condition:** • Water on floor

**Implication(s):** Chance of water damage to structure, finishes and contents

Standing water in basement

*Standing water in basement*
